Detection and analysis of concrete cracks in raft foundation and external wall of a basement

Xuefeng Gao*

Zhangye Architectural Survey and Design Institute Co., Ltd., Zhangye, Gansu, China

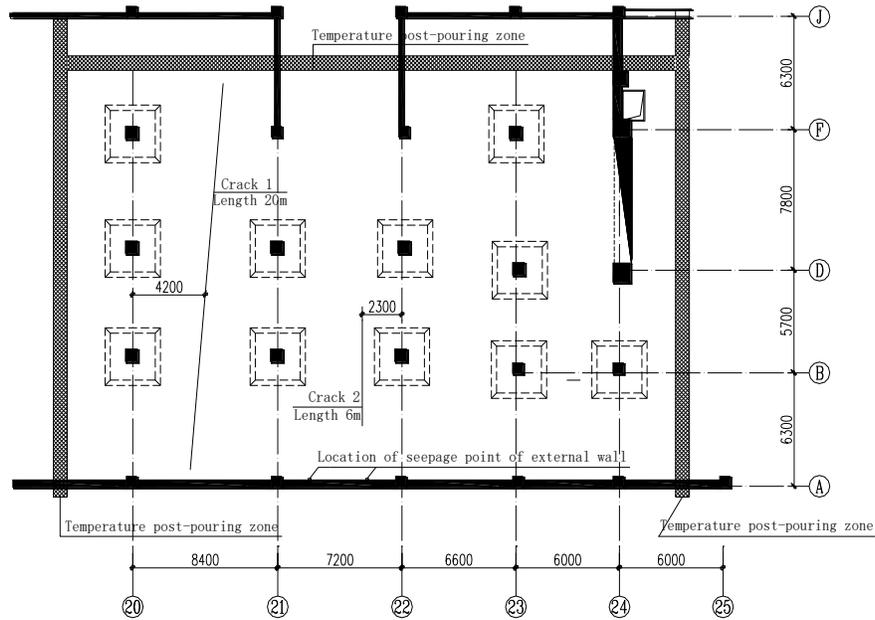
(1) Negative first floor 20~21×A~H axis position basement raft plate crack detection from the field test situation, negative first floor 20~21×A~H axis position basement raft plate stock cracking phenomenon, to the diagonal cracks are mainly (see Figure 1 for the specific location), as can be seen by the actual field observation: (a) From the morphology of the cracks, the cracks are large in the middle and small at both ends; (b) From the degree of crack distribution, the crack width is between 0.1mm and 0.2mm; (c) As can be judged from the water seepage at the location of the cracks at the test site, the cracks have penetrated up and down; (d) Core sampling was carried out at the crack location (see Figure 2 for sampling photos), and it can be seen from the core samples that the cracks within the depth range of the core samples drilled are through cracks, which continue to extend downwards, and the silt carried by the rising water table has already filled some of the cracks in the location⁴.

(2) Crack detection of basement wall at 20-24×A axis location in the second negative floor: From the on-site inspection, the basement wall at the 20-24×A axis position of the negative first floor has different degrees of cracking, mainly vertical cracks, irregularly distributed, as can be seen from the actual on-site observation: (a) In terms of crack morphology, the cracks are large in the middle and small at both ends; (b) From the degree of crack distribution, the width of cracks is between 0.1mm and 0.3mm; (c) From the water seepage at the location of the cracks at the testing site, it can be judged that the cracks have penetrated both inside and outside; from the above, it can be seen that the cracks have also penetrated both inside and outside in some of the areas that have not been flooded by water; (d) Core sampling was carried out at the crack location (see Figure 3 for sampling photos). It can be seen from the core samples that the cracks within the depth

Figure 1. Schematic diagram of concrete crack position.

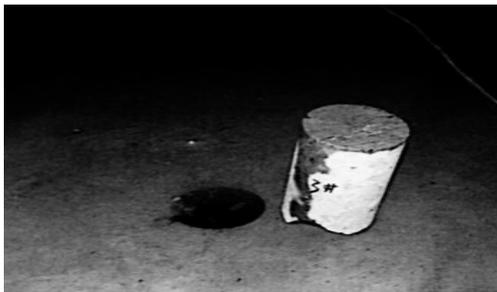
Figure 2. Sampling photo of raft concrete core.

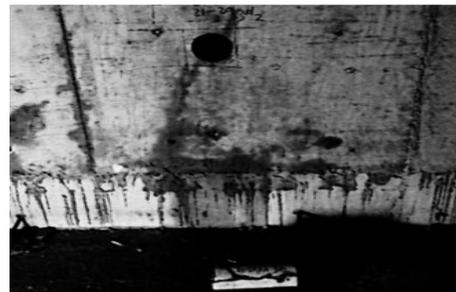
range of the core samples drilled are through cracks, and the cracks continue to extend in the depth direction, and the silt brought by the rising water table has already filled up some of the cracks in the location.

Figure 3. Sampling photo of concrete core of basement wall.

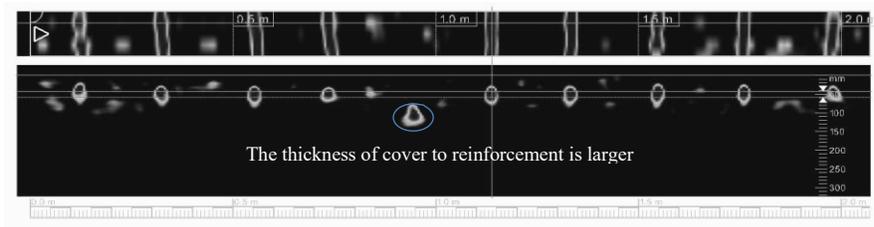
(1) The thickness of the steel bar protective layer above the crack position of the basement raft slab at the 20~21×A~H axis position on the negative second floor of the project was scanned and tested. Judging from the test results, the thickness of the steel bar protective layer at individual positions of the basement raft on the negative second floor is too large and appears near the crack position⁵. The steel bar detection results are as follows (see Figures 4-7):

Figure 4. Detection results of reinforcement at points 1# and 2#.

From the above results of the analysis of the protective layer of reinforcement, it can be seen that the thickness of the protective layer of reinforcement in individual locations of the basement raft slab in the negative two floors was large and appeared in the vicinity of the location of the cracks.

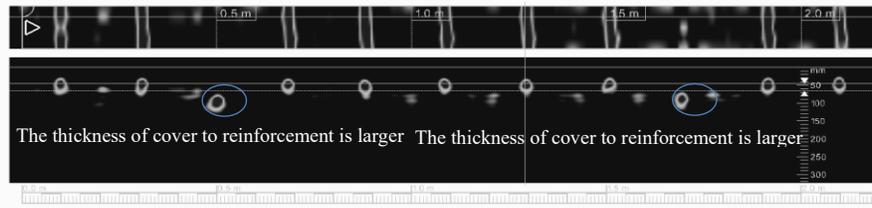
Figure 5. Detection results of reinforcement at point 3#.

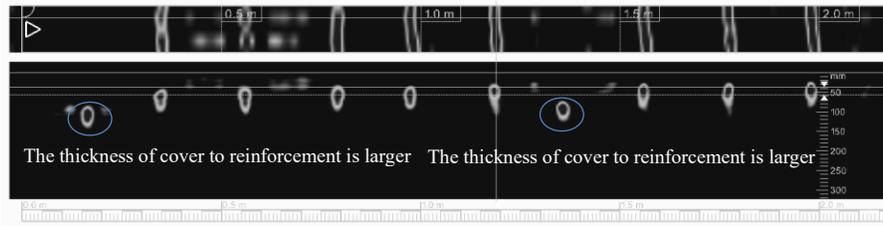
Figure 6. Detection results of rebar at point 4#.

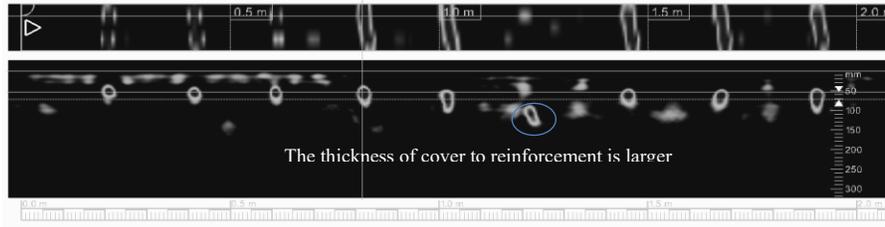
Figure 7. Detection results of reinforcement at point 5#.

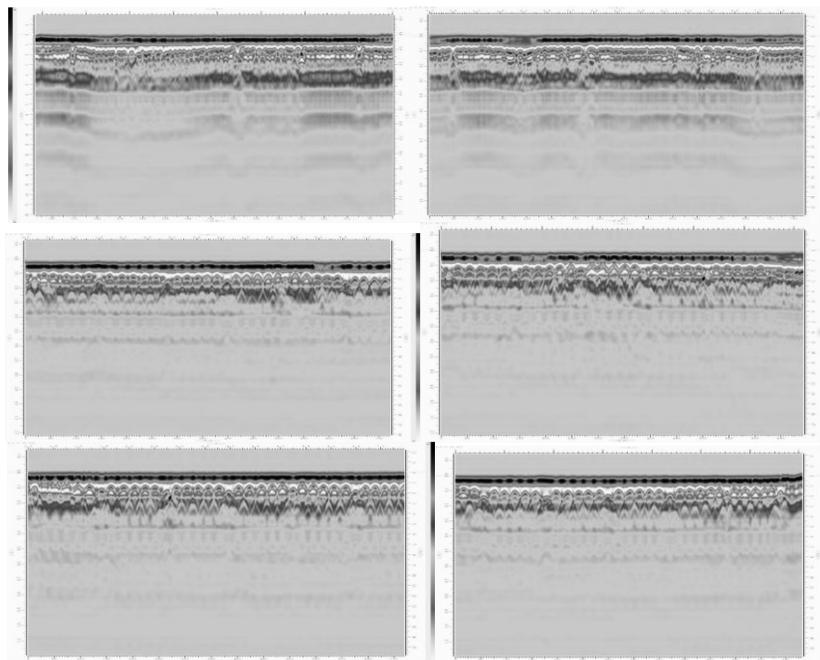
(1) Radar detection was carried out on the basement raft at the 20~21×A~H axis position on the negative second floor of the project. From the detection results, no abnormalities were found on the basement raft of the negative second floor of the project⁷. The specific detection results are as follows (Figure 12):

Figure 12. Radar detection results of basement raft concrete.

It can be seen that the horizontal direction of the basement raft slab at the axial position of 20~21×A~H in the negative first floor of the project has not found any abnormal site, and it can be determined that the horizontal direction of the raft slab at this position has not found any horizontal cracks with large length⁸.

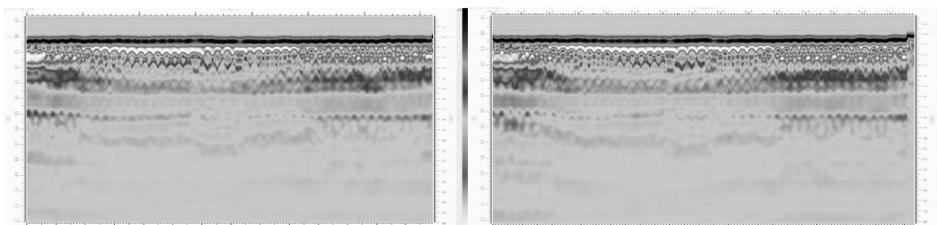
(2) Radar detection is carried out on the basement outer wall of the negative first floor 20~24×A axis position of the project, and no abnormality is found on the basement outer wall of the project from the detection results, which are as follows (Figure 13):

Figure 13. Radar detection results of basement exterior wall concrete.

From the radar analysis results, it can be seen that the project's negative first floor 20~24×A axis location basement wall testing location vertical direction did not find anomalies in the field, it can be determined that the location of the wall inside the wall parallel to the direction of the wall has not been found in the length of the vertical cracks.
